# RELIABILITY STUDY OF OPTO-COUPLED SEMICONDUCTOR DEVICES AND LIGHT EMITTING DIODES (LED)

## FINAL TECHNICAL REPORT

OCTOBER 1974 — OCTOBER 1977

MCDONNELL DOUGLAS ASTRONAUTICS COMPANY - EAST

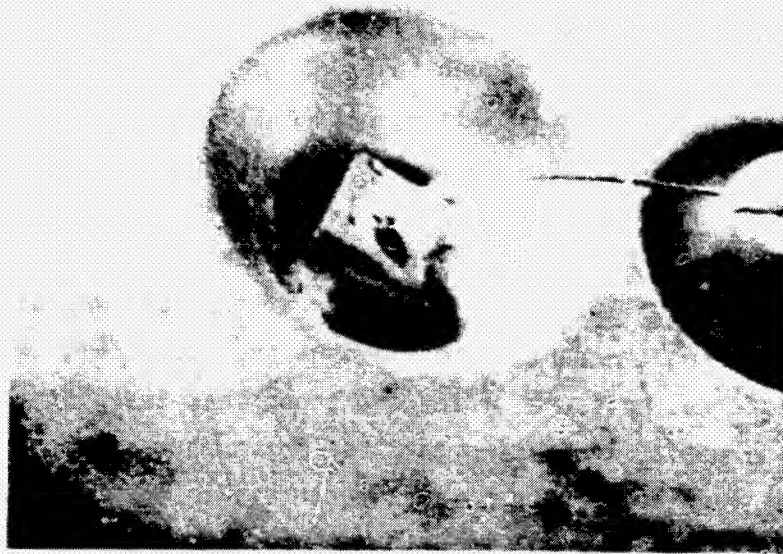
70X RCA S/N 323 (168 HRS/225°C ACCEL. LIFE)

FIGURE E34 - LOOSE DIE THAT RESULTED FROM MIGRATION OF THE SILVER EPOXY.
